Written Comments #1 from Susan Wilkins – August 20, 2014

Attached are two photos of downtown Redmond and Bear Creek as it flows south-southwest through the city. The black & white photo was obtained from the King County Archives. The back of the photo is stamped "Photograph by King County Engineer's Office" and is dated Jan 2, 1964. The color aerial photo was taken in 2009 (copied from the King County iMap site.) Both photos are looking southwest.

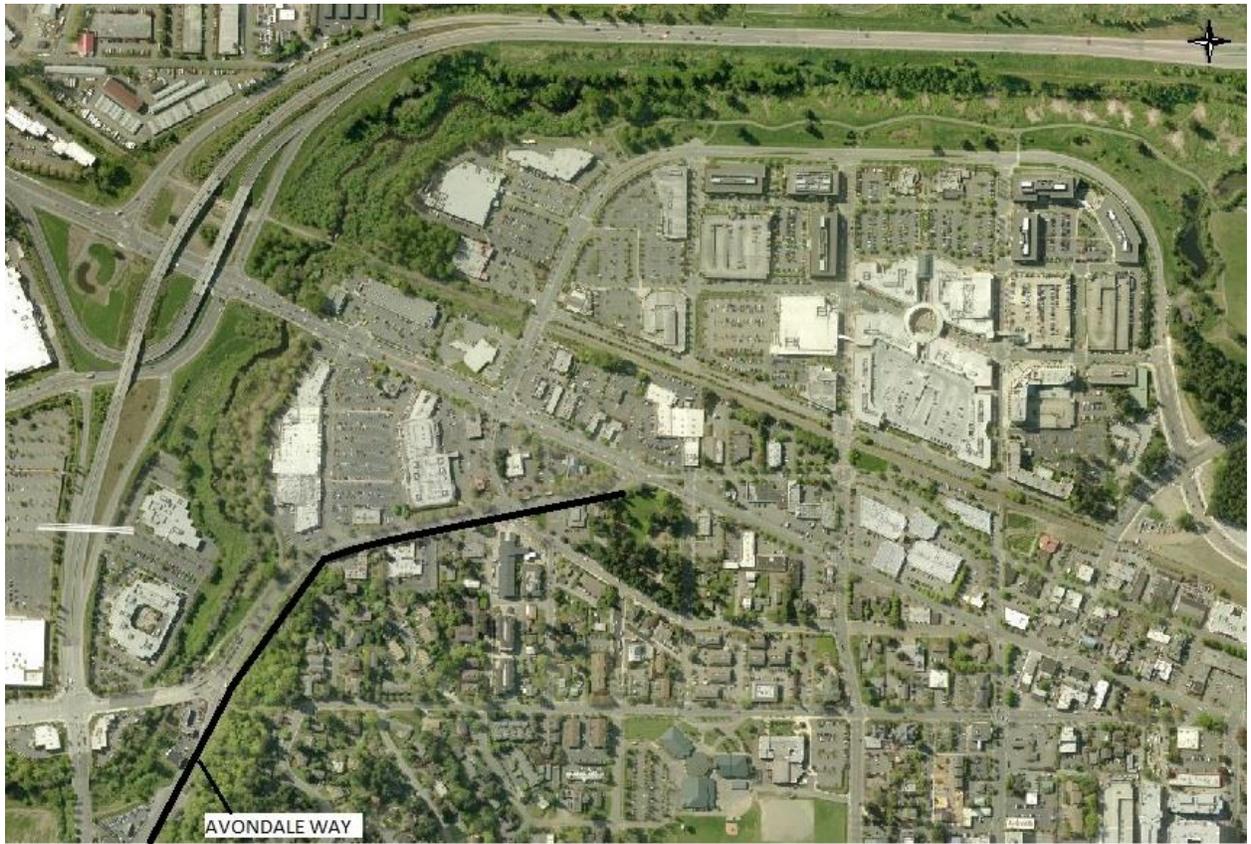
In the black and white photo, Avondale Way is in the bottom right corner and the baseball diamond is where the Bear Creek Shopping Center is now located. In the color photo, Avondale Way has been traced with a black line.

Downtown Redmond is built in an abandoned glacial river channel that used to become swampy and flooded following a typical heavy rain. All of the construction over the past 50 years has limited the amount of flood storage available to a narrow strip along Bear Creek.

Because it was a riverbed, the sediments under the city were a mix of porous sand and gravel so floodwaters would quickly seep into the ground. The downtown is now nearly 100% impervious surface. More significantly, the sand and gravel deposits under the city have been replaced by underground parking garages, further reducing the storage capacity for floodwater. These parking garages can fill with floodwater if there is too much rainwater for the storm sewer system to handle.

The Keller Farm can contain floodwater flowing downstream along Bear and Evans Creeks in order to mitigate flooding during major storm events. Preserving flood storage capacity on the entire farm should be part of the critical storm water plan for the city.
