Appendix C: Stream and Fish Report

**Re: Stream Enhancement and Fish Use Possibilities at Sammamish Valley Park** Watershed Company Reference Number: 080906

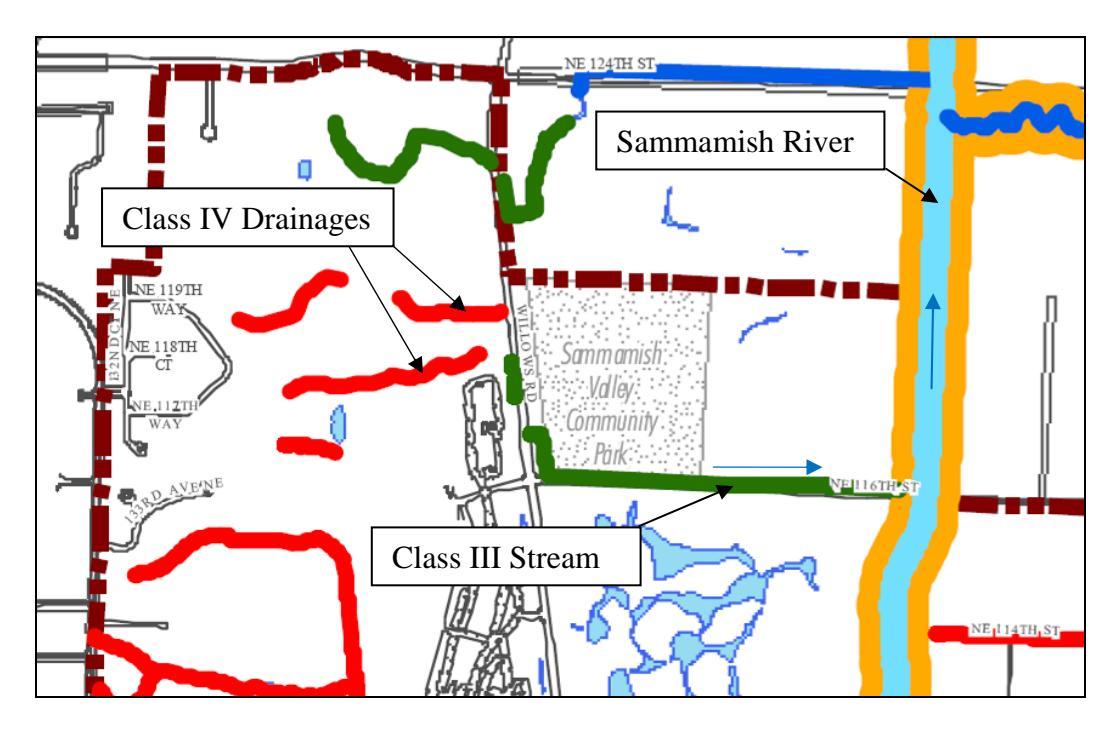
Figure 1. From City of Redmond Streams Classification Mapping.

City of Redmond stream mapping indicates the presence of a Class III stream flowing southward along the west boundary of Sammamish Valley Park (east side of Willows Road), then eastward along the south property boundary (north side of NE 116<sup>th</sup> Street; see Figure 1, below). This stream, identified as Stream A in the wetland delineation report, originates from the confluence of several Class IV drainages originating on the slopes extending upwards west of Willows Road. Downstream of the Sammamish Valley Park site, the stream continues eastward along an artificial, ditch-like channel along the north side of NE 116<sup>th</sup> Street, passing an adjacent parcel to join the Sammamish River on its west bank immediately downstream of NE 116<sup>th</sup> Street.

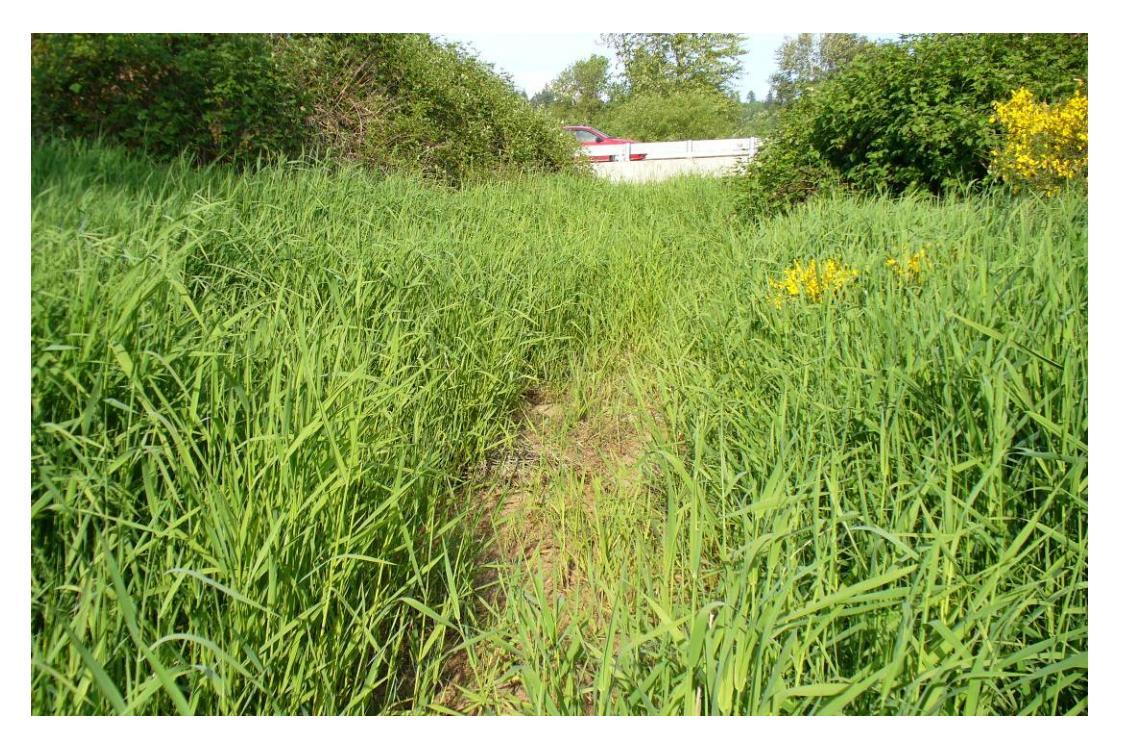
Photo 1 – View eastward along the Class III drainage channel. Note reed canarygrass and exposed bed as a sign of previous standing water.

southward along Willows Road then eastward along NE 116<sup>th</sup> Street to the Sammamish River. This artificial channel was dry along its entire length on June 1, 2009, consisting primarily of a reed-canarygrass-choked swale with evidence of flow or at least standing water having been present during wetter periods (see Photo 1). At the river, any flow would pass through a 36-inch CMP through the levee along the river to be discharged down a steep, rocky riverbank, typically 4 to 5 feet vertically above the river surface under low or base flow conditions (see Photo 2).

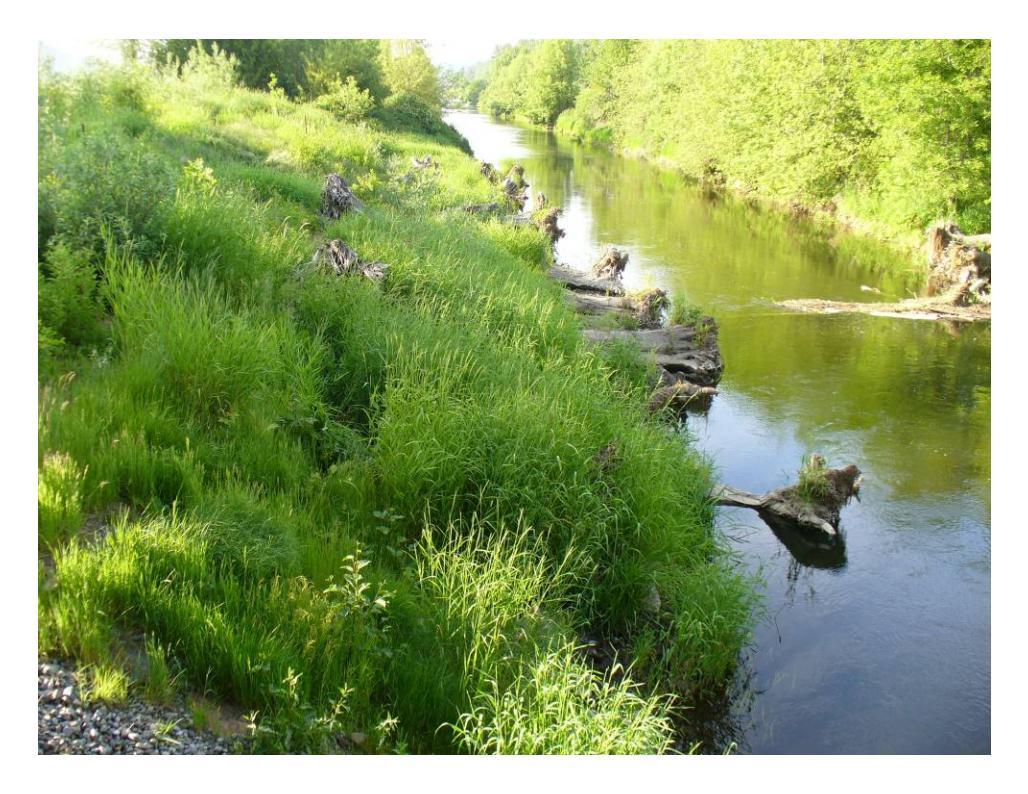
Photo 2 – Facing downstream, northward along the Sammamish River; the culvert outfall for Stream A is under the reed canarygrass partway up the bank on the left side of the photo.

Given 1) the perched outfall of the culverted stream outlet 4 to 5 feet up a steep bank above the river, and 2) the long stretches of only seasonally-flowing channel between the river and the site, it is doubtful that a reliable connection exists, or could be feasibly made, for fish to access the stream sections on or near the site from the river. Furthermore, the gradient of the culvert at the outlet is somewhat steeper – estimated at approximately 4 percent - than would be ideal or acceptable for fish passage. Basically, the river would have to be at flood stage to backwater the culvert and provide ease of passage into the Class III, Stream A system.

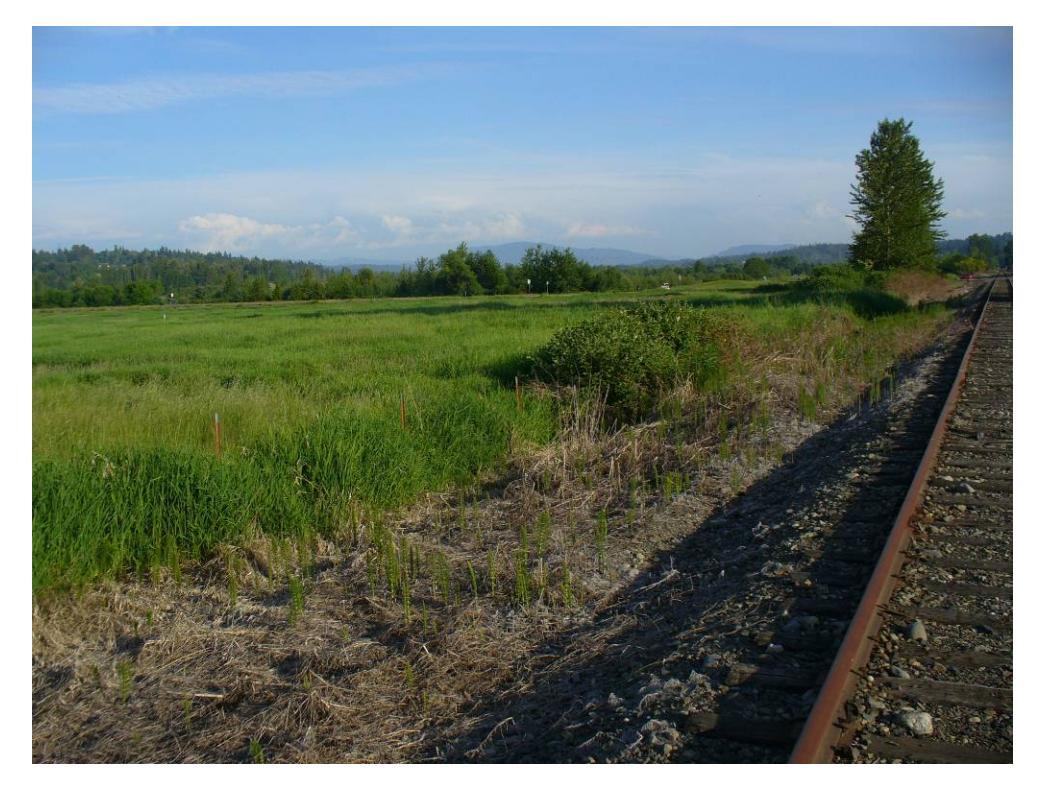
Photo 3 – Area envisioned for the creation of ponds or open water wetlands that will increase the overall diversity of wildlife habitat, including habitat for amphibians and the provision of limited fish habitat.

Due to space and gradient constraints, there would be little opportunity to create classic pool/riffle stream channel sections with a gravel substrate on-site. Rather, it is envisioned that any creation of fish habitat in conjunction with the wetland and other habitat enhancements being planned for the site would consist of low-banked channel sections with slow-moving water and/or ponded or open water wetland areas to be excavated near the west site boundary. Such features would be supplied with water from Stream A where it presently disperses into the wetlands on-site (see Photo 3). From these created ponds or ponded areas, water could continue to disperse eastward across the site, similarly to what it does now, to supply water (wetland hydrology) to existing and/or to-be-enhanced or created wetland areas.

An emphasis on native, non-salmonid fish is recommended. Certain of these fish can generally stand warmer water temperatures and lower dissolved oxygen levels than can salmonid fish. Examples of potentially-suited species include, but are not limited to, three-spined stickleback, Olympic mudminnow, and speckled dace. Somewhat of a curiosity due to their rarity, Olympic mudminnow have been collected locally in Cherry and Issaquah Creeks (Inland Fishes of Washington, Wydoski and Whitney, Second Edition, 2003), and may be suited to the type of habitat that would be created. Numerous other non-native, but endemic, species would also take well to such ponds or ponded habitat, including brown bullhead catfish and pumpkinseed sunfish. Cooperation with the Washington Department of Fish and Wildlife would be necessary in order to plant any fish species, native or not, into any habitat created for fish on-site.
